Service Bulletin

SUBJECT: Service Update for Inventory and Customer Vehicles
Underbody Appearance
Expires with Base Warranty

MODELS: 2014 Chevrolet Silverado 1500
2014 GMC Sierra 1500

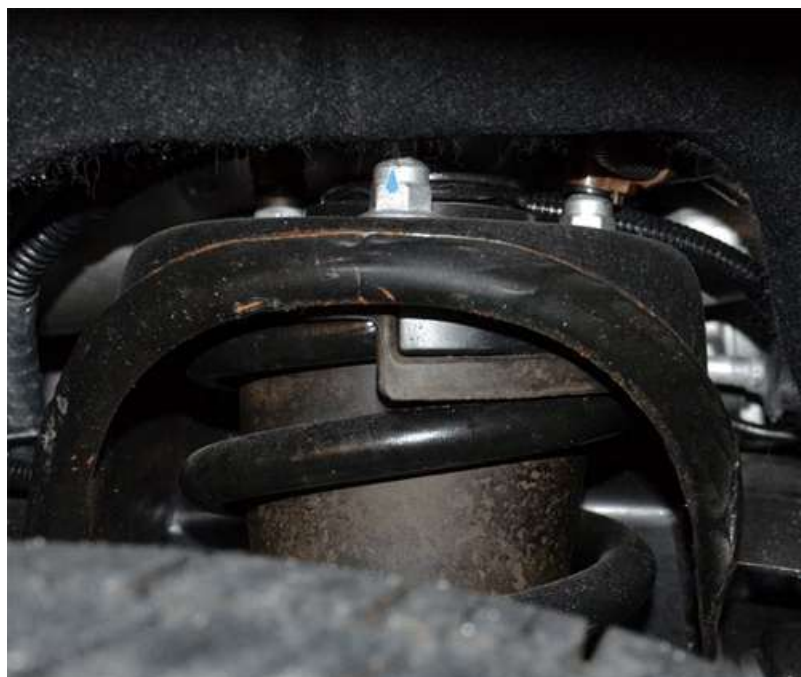
3686530

- Front spring mounts (visible through wheelhouse)

No Repair Required

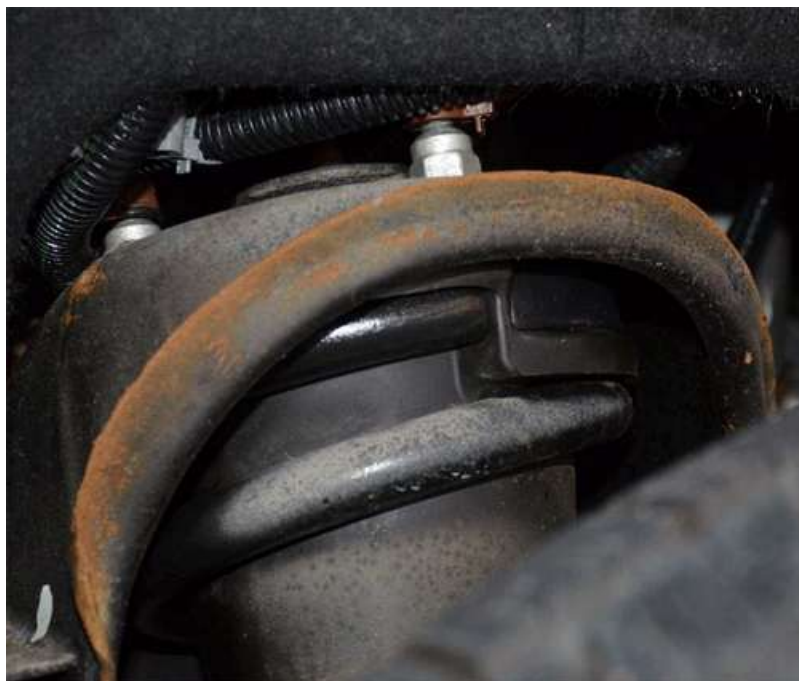
3686529

Repair Required

1. Any loose rust or coating should be wire brushed off.
2. Using a rag and general purpose adhesive remover, wipe down the affected repair area.
3. For the front spring mounts, frame and body mounts, apply a coat of Daubert Nox-Rust® P/N X-121B “One Coat Rust Preventative Coating” (aerosol), or equivalent.
4. For the rear axle assembly and rear shock mounts, apply a coat of Lloyds Kryptonite Metal Treatment P/N 36502 Life Long Rust Protection (14 ounce aerosol), or equivalent.

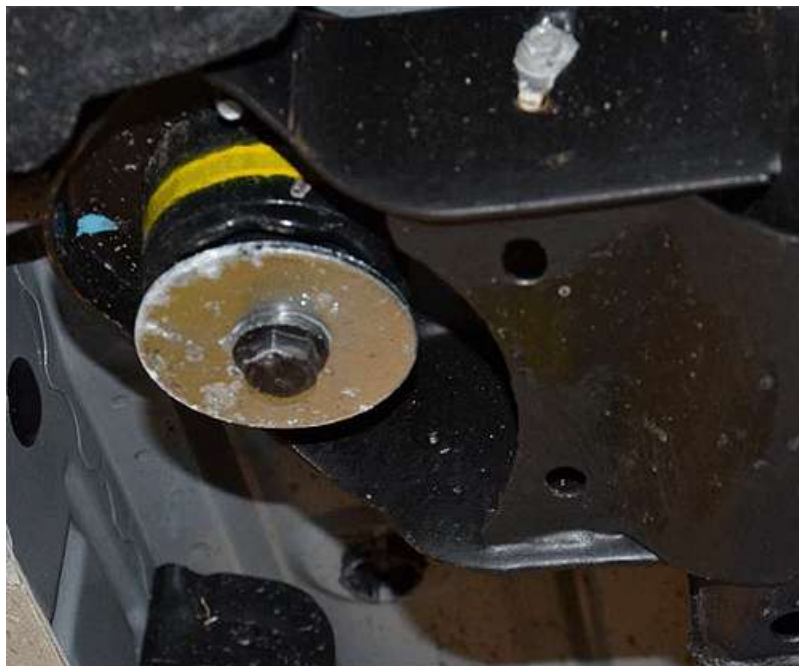
3686510

- Body mounts (visible underneath door(s))

No Repair Required

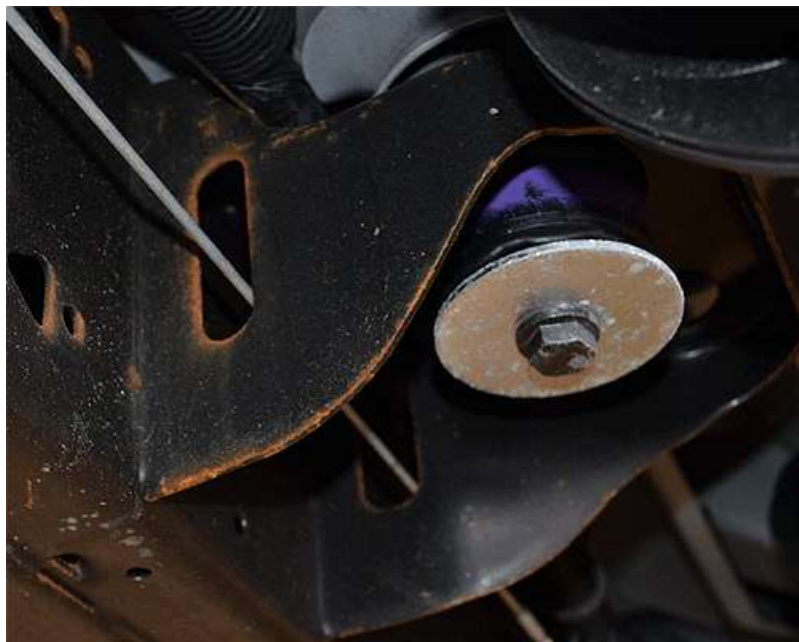
3686508

Repair Required

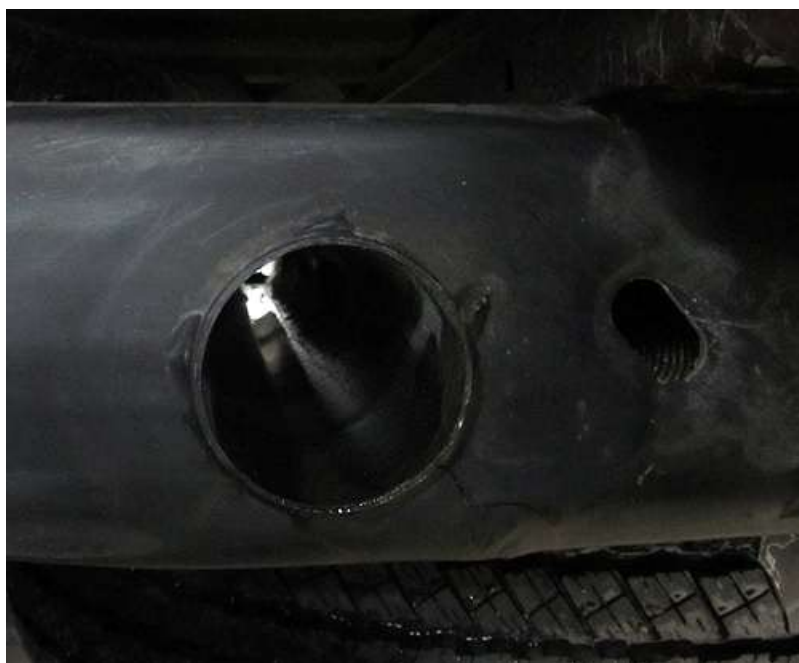
3687198

- Frame and flanges (visible through wheelhouse and underneath door(s))

No Repair Required

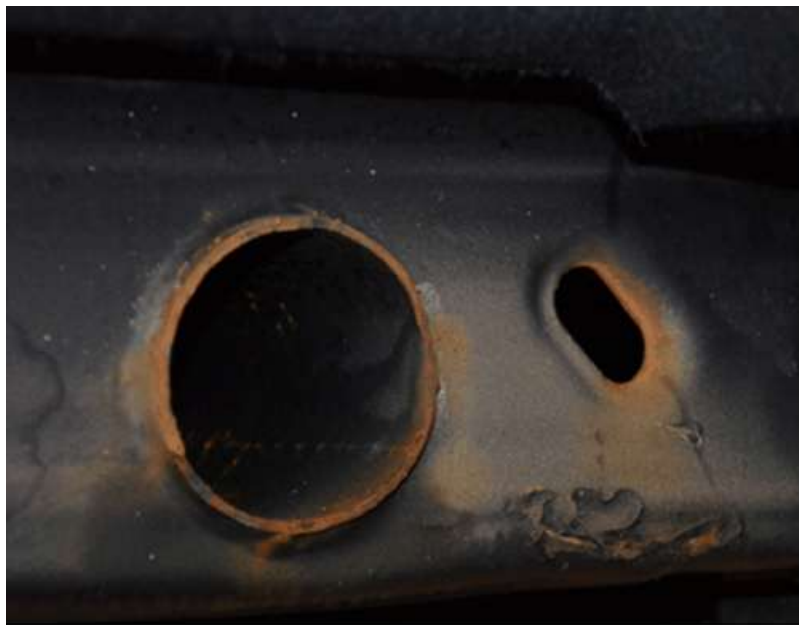
3687196

Repair Required

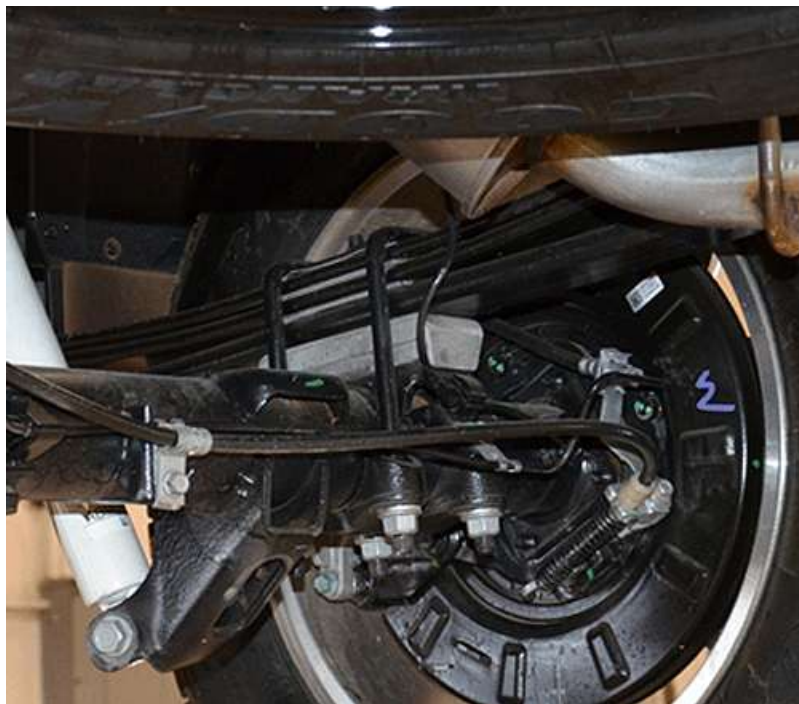
3687935

- Rear shock lower mounts

No Repair Required

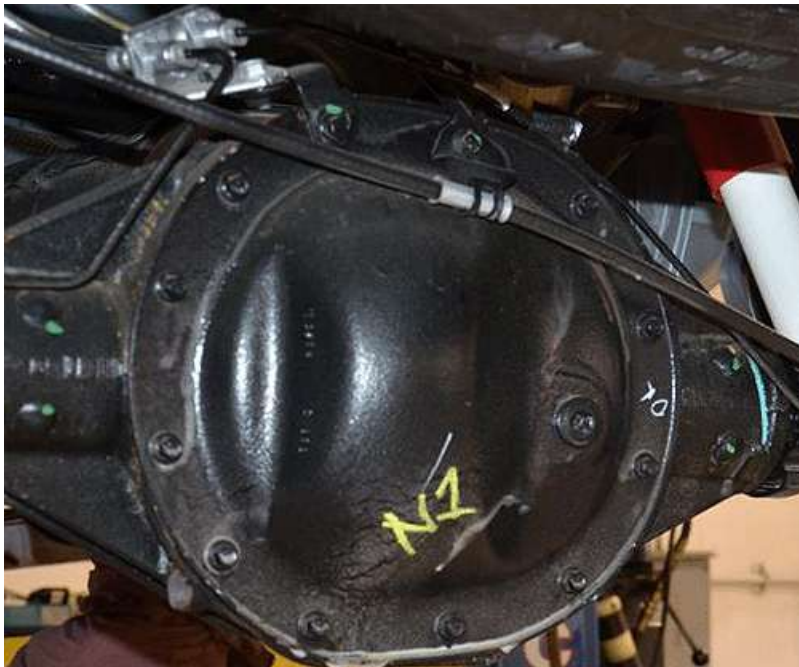
3686527

- Rear axle assembly

No Repair Required
